## Penetrant test report

**Report number** LW26-0253-03 PT  
**Customer name** AAS STEEL PTY LTD  
**Address** 9 Trade Place Pakenham VIC Australia 3810  
**Requested by** Shan Senn

**Job description** Visible dye penetrant testing on 350NB header weldments  
**Identification** Job: VMM00120 NEXT DC M3 STAGE 2; Drawing: SDRG-B-0201-8241

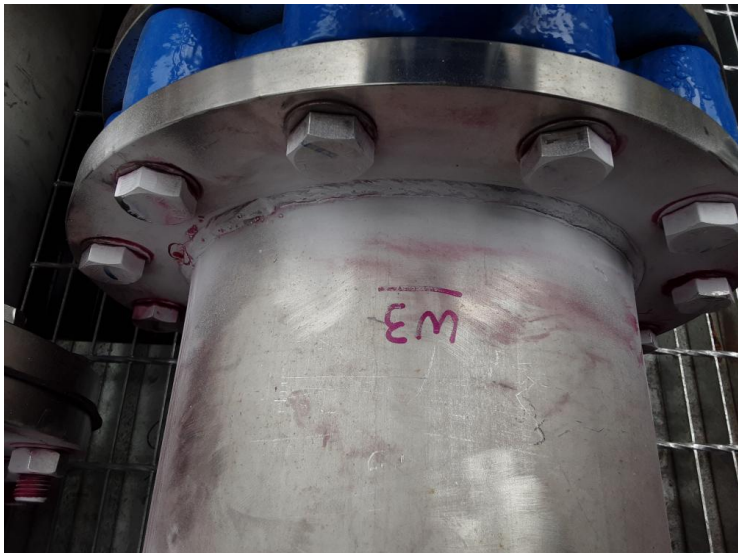
| Identification | Spool No. | Weld No. | Description | Discontinuities |
|---|---|---|---|---|
| North end | Spool 4 | 3 | Bottom header | 5 off lack of fusion between 5mm and 40mm |

Image 1 of 11 - W3: 5 off indications @ 8, 9, 5, 7 and 3 o'clock facing west

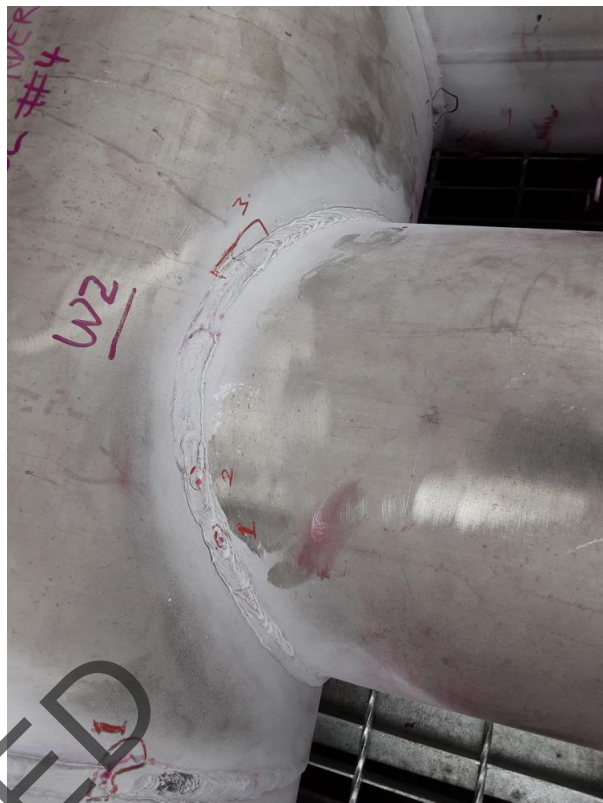
| Identification | Spool No. | Weld No. | Description | Discontinuities |
|---|---|---|---|---|
| North end | Spool 4 | 2 | Bottom header | 2 off rounded indications 2mm, 1 off over roll 30mm, 1 off lack of fusion 30mm |

Image 2 of 11 - W2: 4 off indications @ 11, 1 and 6 o'clock facing east

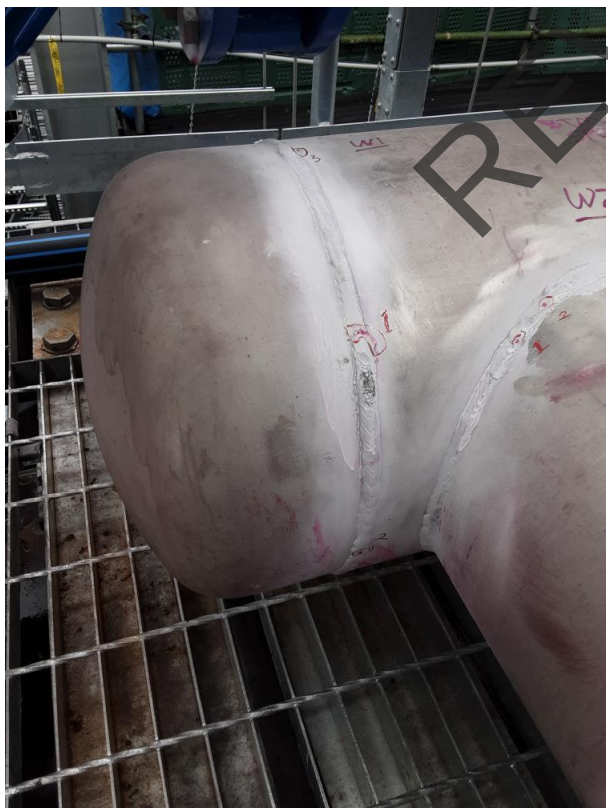
| Identification | Spool No. | Weld No. | Description | Discontinuities |
|---|---|---|---|---|
| North end | Spool 4 | 1 | Bottom header | 2 off lack of fusion 15mm and 5mm , 1 off gas pore 3mm |

Image 3 of 11 - W1: 3 off indications @ 8, 10 and 12 o'clock facing north

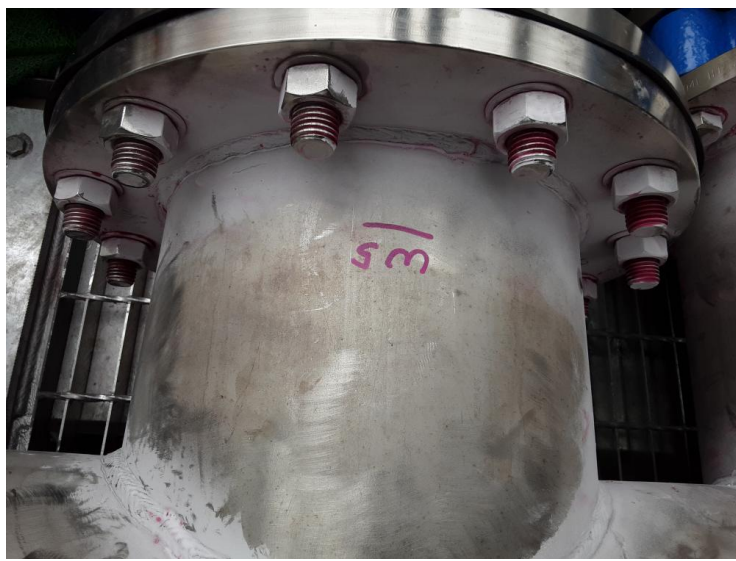
| Identification | Spool No. | Weld No. | Description | Discontinuities |
|---|---|---|---|---|
| North end | Spool 4 | 4 | Bottom header | 4 off lack of fusion between 10mm and 40mm and 3 off gas pores 2mm |

Image 4 of 11 - W4: 7 off indications @ 1, 3, 5, 7, 8 and 9 o'clock facing east

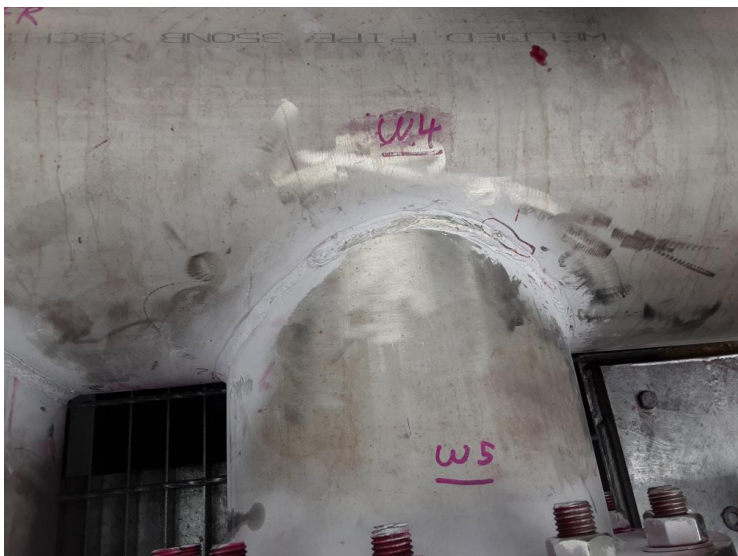
| Identification | Spool No. | Weld No. | Description | Discontinuities |
|---|---|---|---|---|
| North end | Spool 4 | 5 | Bottom header | 4 off lack of fusion between 5mm and 20mm and 1 off gas pore 2mm |

Image 5 of 11 - W5: 5 off indications @ 9, 3, and 5 o'clock facing west

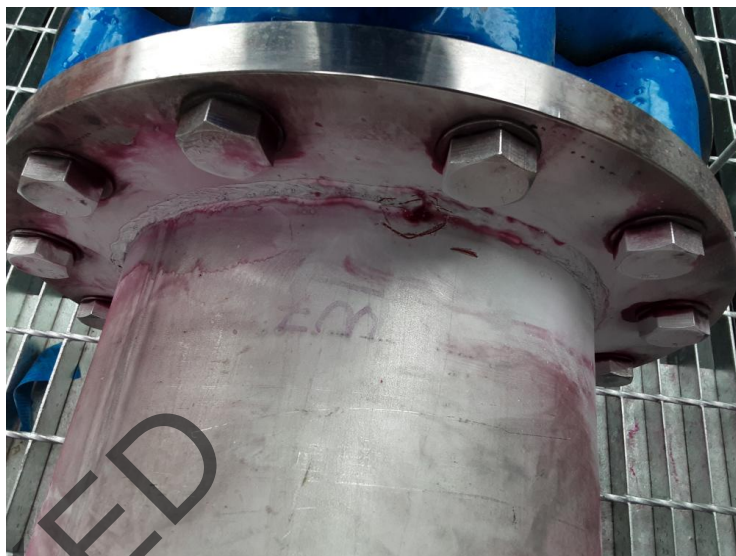
| Identification | Spool No. | Weld No. | Description | Discontinuities |
|---|---|---|---|---|
| North end | Spool 4 | 7 | Bottom header | 4 off lack of fusion between 5mm and 40mm and 1 off gas pore 2mm |

Image 6 of 11 - W7: 5 off indications @ 12, 9, and 6 o'clock facing west

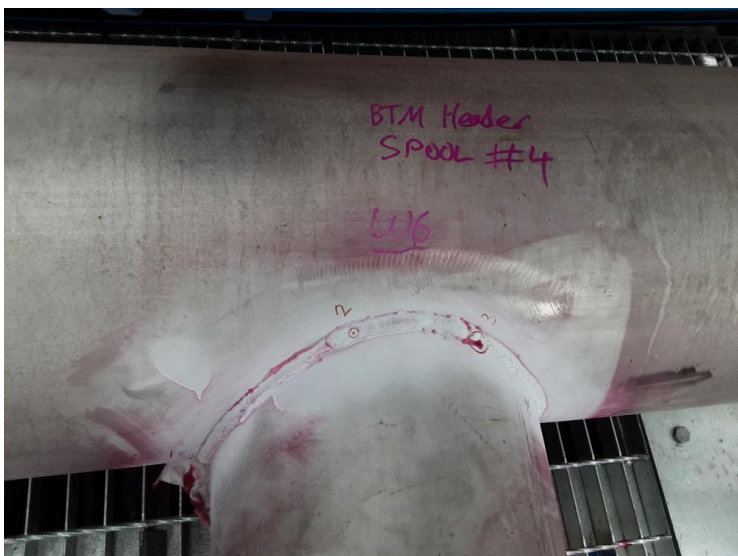
| Identification | Spool No. | Weld No. | Description | Discontinuities |
|---|---|---|---|---|
| North end | Spool 4 | 6 | Bottom header | 2 off lack of fusion between 5mm and 20mm and 1 off gas pore 2mm |

Image 7 of 11 - W6: 3 off indications @ 9, 11, and 12 o'clock facing east

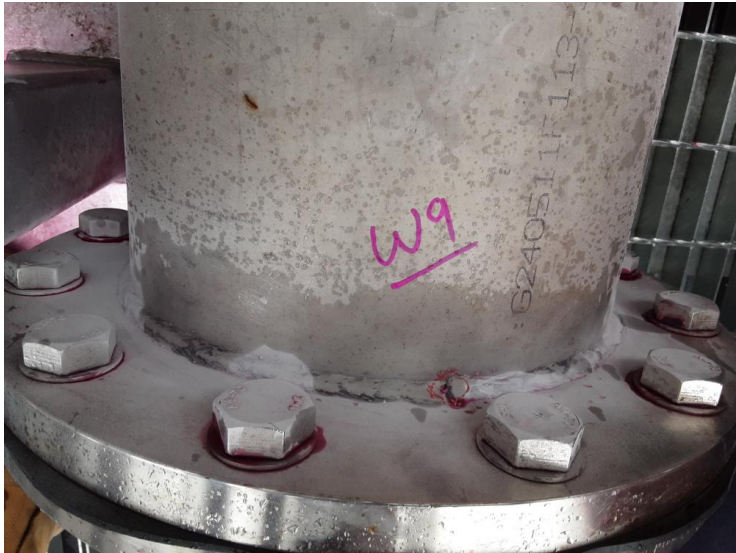
| Identification | Spool No. | Weld No. | Description | Discontinuities |
|---|---|---|---|---|
| North end | Spool 4 | 9 | Bottom header | 3 off lack of fusion between 5mm and 40mm |

Image 9 of 11 - W9: 3 off indications @ 4, 11, and 7 o'clock facing west

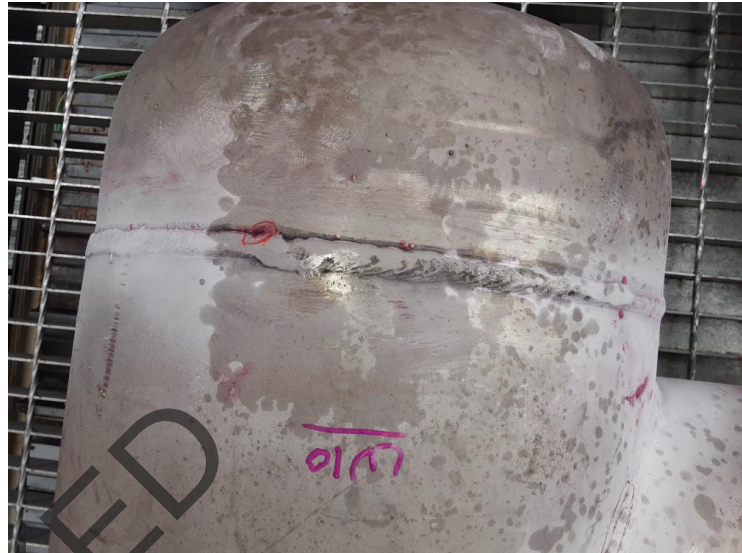
| Identification | Spool No. | Weld No. | Description | Discontinuities |
|---|---|---|---|---|
| North end | Spool 4 | 10 | Bottom header | 5 off lack of fusion between 5mm and 50mm |

Image 10 of 11 - W10: 3 off indications @ 6, 3, and 12 o'clock facing north

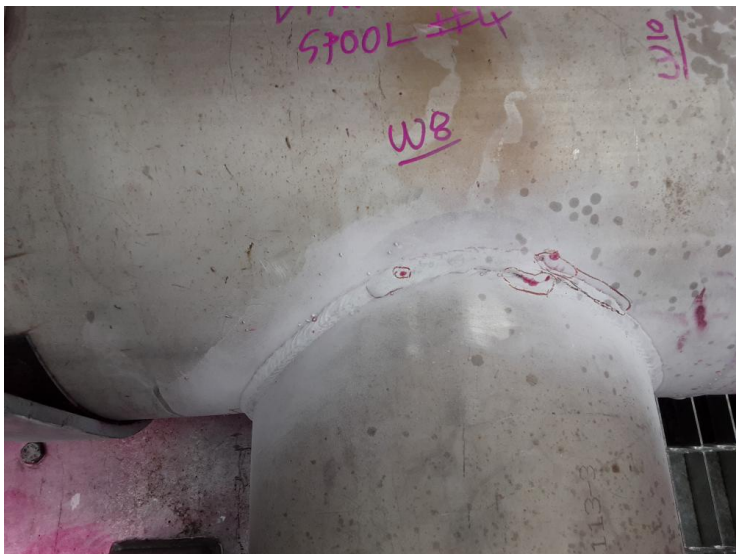
| Identification | Spool No. | Weld No. | Description | Discontinuities |
|---|---|---|---|---|
| North end | Spool 4 | 8 | Bottom header | 4 off lack of fusion between 20mm and 40mm and 1 off gas pore 2mm |

Image 11 of 11 - W8: 6 off indications @ 9, 11, 1, 3 and 6 o'clock facing east
