## Penetrant test report

**Report number** LW26-0253-08 PT

**Job description** Visible dye penetrant testing on 350NB header weldments

**Identification** Job: VMM00120 NEXT DC M3 STAGE 2; Drawing: SDRG-B-0201-8241

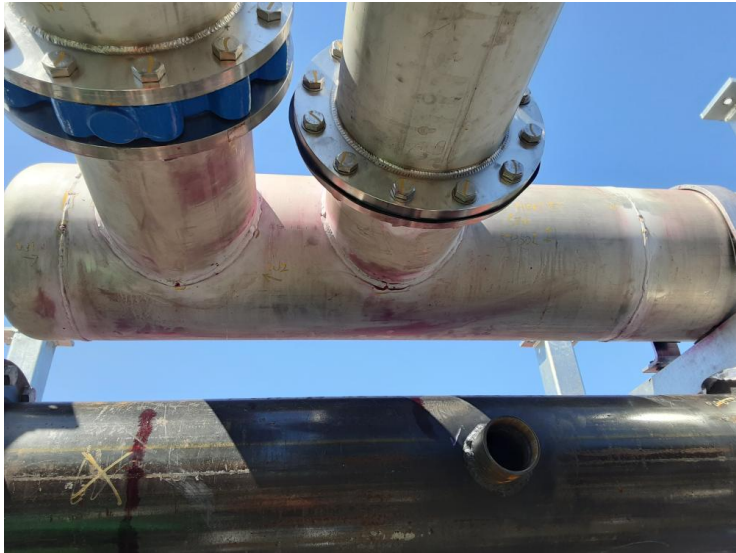
Image 1 of 9 - Top header South end spool #1 W1-6

| Identification | Spool No. | Weld No. | Description | Test area | Discontinuities |
|---|---|---|---|---|---|
| South end | Spool 1 | 1 | Top header | 6-12 o'clock Facing north | 3 off locations of SUC(E) each 40mm |
| South end | Spool 1 | 2 | Top header | Entire Facing east | LS80 @ 3ocl, CC5 @ 6ocl, LS100 @ 5-6ocl, LS10 @ 9ocl, LS20 @ 11ocl |
| South end | Spool 1 | 3 | Top header | Entire Facing west | CC10 @ 8ocl, LS40 @ 8ocl, LS30 @ 6ocl |
| South end | Spool 1 | 4 | Top header | Entire Facing east | LS30 @ 3ocl, LS30 @ 3ocl, excessive weld cap 100 @ 3ocl, LS10 @ 9ocl |
| South end | Spool 1 | 5 | Top header | Entire Facing west | LS30 @ 6ocl, CC20 @ 6ocl, LS30 @ 12ocl |
| South end | Spool 1 | 6 | Top header | 6-12 Facing north | CC5 @ 3ocl, SUC(E)50 @ 2ocl, SUC(E)40 @ 1ocl |

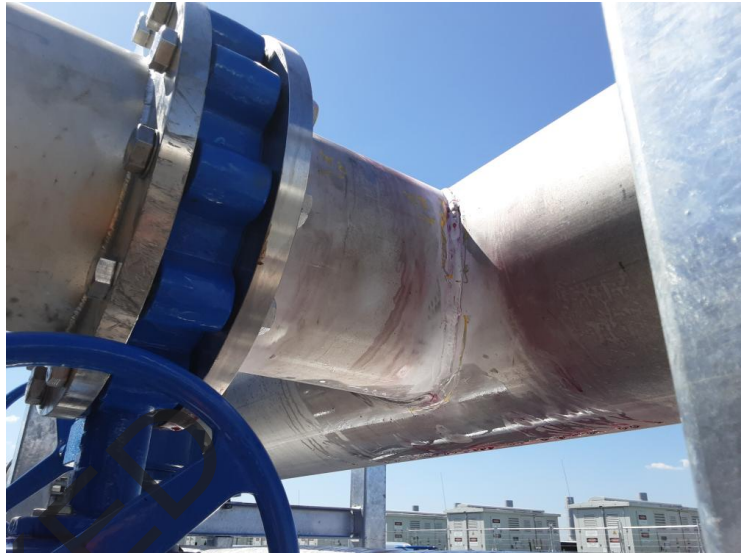
Image 2 of 9 - Top header South end spool #1 W7 & 8

| Identification | Spool No. | Weld No. | Description | Test area | Discontinuities |
|---|---|---|---|---|---|
| South end | Spool 1 | 7 | Top header | Entire Facing west | Intermittent LS @ 12-1 ocl, LS35 @ 11ocl, excessive weld cap @ 2-3, LS100 @ 3ocl, LS300 @ 5-9ocl, LS30 @ 9ocl, excessive weld cap @ 9ocl |
| South end | Spool 1 | 8 | Top header | Entire Facing east | LS30 @ 6ocl, CC5 @ 4ocl |

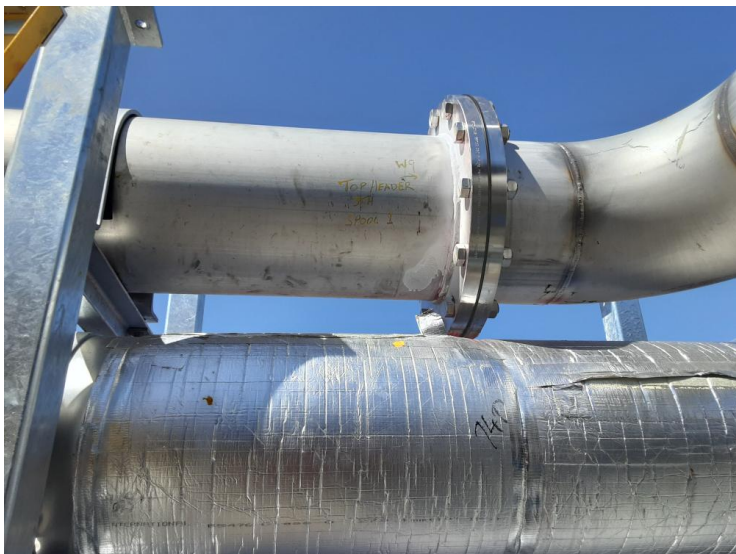
Image 3 of 9 - Top header South end spool #1 W9

| Identification | Spool No. | Weld No. | Description | Test area | Discontinuities |
|---|---|---|---|---|---|
| South end | Spool 1 | 9 | Top header | 12-6 Facing south | LS50 @ 6ocl |

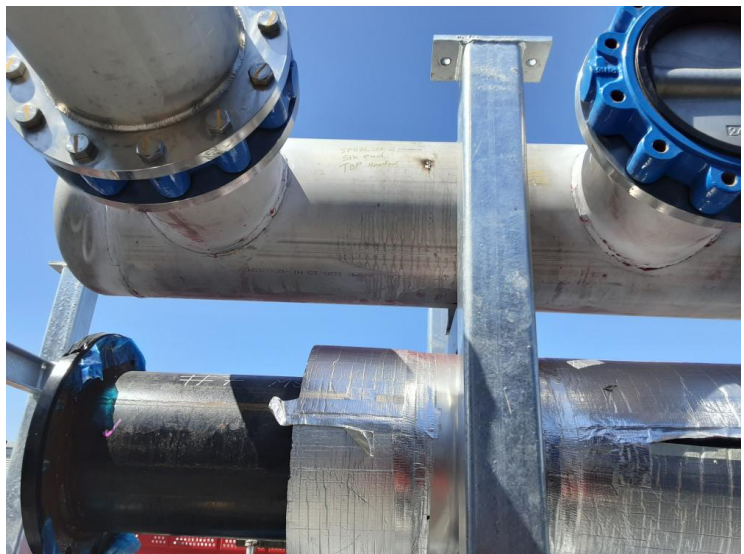
Image 4 of 9 - Top header South end spool #2 W1-5

| Identification | Spool No. | Weld No. | Description | Test area | Discontinuities |
|---|---|---|---|---|---|
| South end | Spool 2 | 1 | Top header | 6-12 Facing north | KL10 @ 12ocl, LS10 @ 10ocl, LS25 @ 9ocl, LS25 @ 6ocl |
| South end | Spool 2 | 2 | Top header | Entire Facing east | LS10 @ 12ocl, LS80 @ 3ocl, LS15 @ 4ocl, CC10 @ 5ocl, LS10 @ 5ocl, LS60 @ 6ocl, CC5 @ 7ocl, CC20 @ 8ocl, LS10 @ 9ocl, CC5 @ 10ocl, LS20 @ 10ocl, LS20 @ 11ocl |
| South end | Spool 2 | 3 | Top header | Entire Facing west | LS15 @ 2ocl, LS30 @ 6ocl, LS30 @ 6ocl, LS20 @ 7ocl, LS20 @ 3ocl, LS20 @ 8ocl |
| South end | Spool 2 | 4 | Top header | Entire Facing east | LS20 @ 12ocl, LS40 @ 2ocl, LS60 @ 3ocl, LS25 @ 4ocl, CC5 @ 4ocl, LS35 @ 6ocl, LS40 @ 7ocl, LS20 @ 9ocl, LS15 @ 9ocl, LS15 @ 11ocl |
| South end | Spool 2 | 5 | Top header | Entire Facing west | LS15 @ 9ocl, LS40 @ 6ocl, LS15 @ 3ocl |

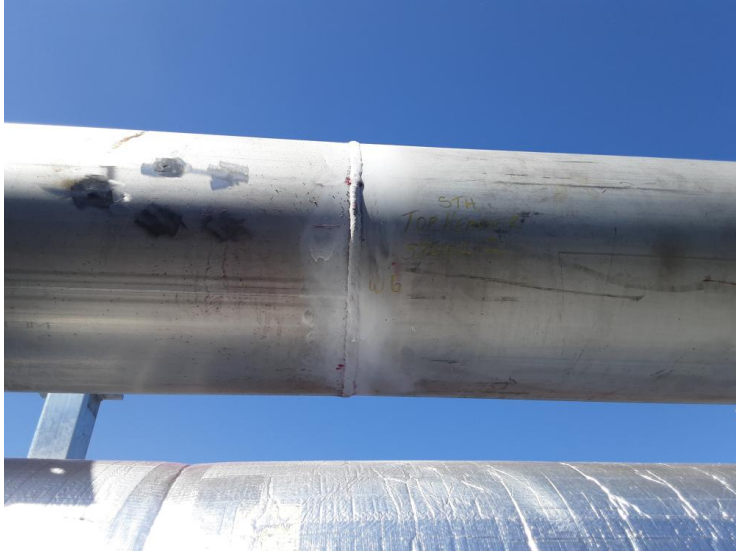
Image 5 of 9 - Top header South end spool #2 W6

| Identification | Spool No. | Weld No. | Description | Test area | Discontinuities |
|---|---|---|---|---|---|
| South end | Spool 2 | 6 | Top header | 6-12 Facing north | LS10 @ 11ocl, GP2 @ 11ocl, LS10 @ 9ocl |

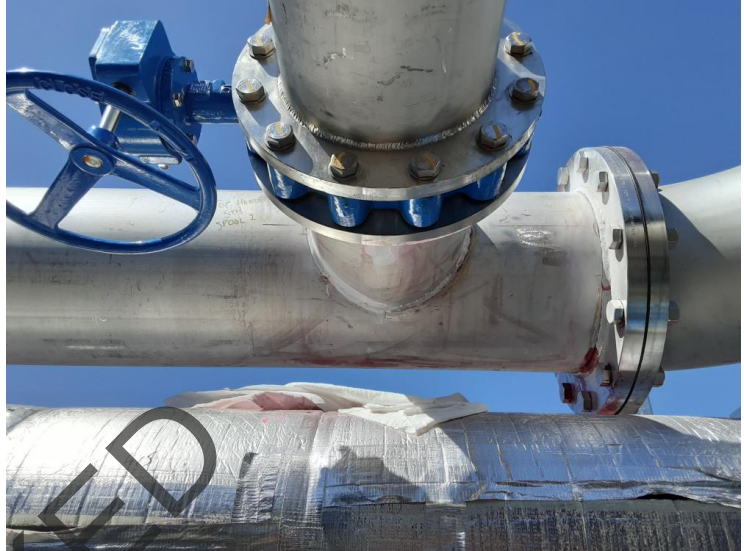
Image 6 of 9 - Top header South end spool #2 W7-9

| Identification | Spool No. | Weld No. | Description | Test area | Discontinuities |
|---|---|---|---|---|---|
| South end | Spool 2 | 7 | Top header | Entire Facing west | LS20 @ 2ocl, LS250 @ 3-6ocl, LS20 @ 8ocl, LS30 @ 9ocl, CC5 @ 11ocl |
| South end | Spool 2 | 8 | Top header | Entire Facing east | LS30 @ 6ocl, LS15 @ 8ocl |
| South end | Spool 2 | 9 | Top header | 12-6 Facing south | LS200 @ 4-6ocl, LS30 @ 3ocl |

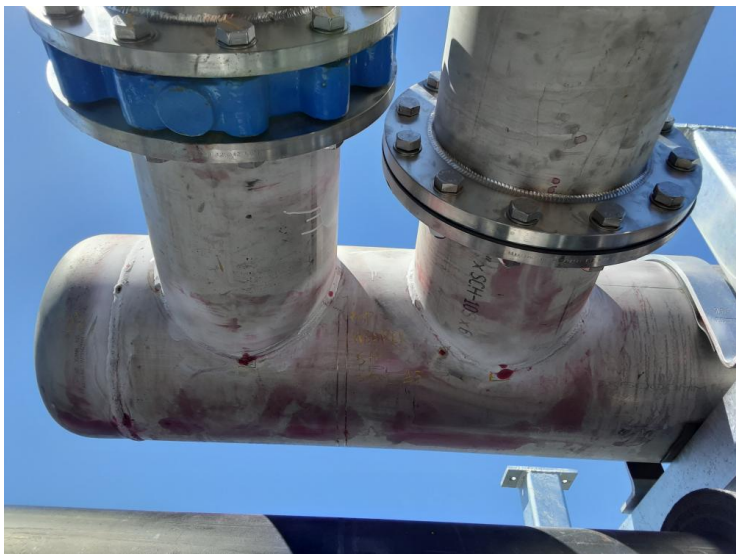
Image 7 of 9 - Top header South end spool #3 W1-5

| Identification | Spool No. | Weld No. | Description | Test area | Discontinuities |
|---|---|---|---|---|---|
| South end | Spool 3 | 1 | Top header | 6-12 Facing north | GP2 @ 9ocl, CC5 @ 9ocl, LS30 @ 6ocl |
| South end | Spool 3 | 2 | Top header | Entire Facing east | LS25 @ 12ocl, CC5 @ 1ocl, LS20 @ 3ocl, CC8 @ 4ocl, LS15 @ 4ocl, LS30 @ 6ocl, GP2 @ 6ocl |
| South end | Spool 3 | 3 | Top header | Entire Facing west | CC10 @ 1ocl, LS150 @ 6ocl, CC5 @ 9ocl, LS20 @ 9ocl |
| South end | Spool 3 | 4 | Top header | Entire Facing east | LS40 @ 12ocl, LS40 @ 2ocl, LS15 @ 9ocl, LS10 @ 6ocl, LS20 @ 6ocl, Hole2 in PM @ 7ocl |
| South end | Spool 3 | 5 | Top header | Entire Facing west | LS40 @ 3ocl, LS30 @ 9ocl |

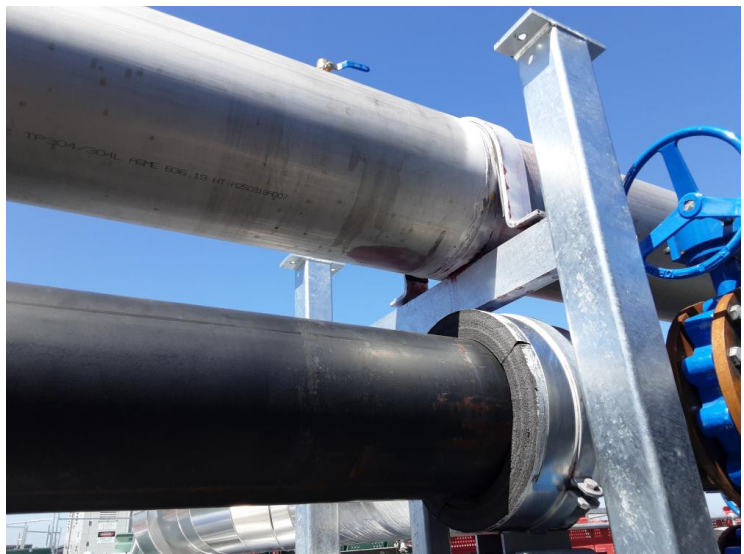
Image 8 of 9 - Top header South end spool #3 W6

| Identification | Spool No. | Weld No. | Description | Test area | Discontinuities |
|---|---|---|---|---|---|
| South end | Spool 3 | 6 | Top header | 6-12 Facing north | LS25 @ 4ocl, LS70 @ 6ocl, LS30 @ 6ocl, test restriction saddle masking HAZ |

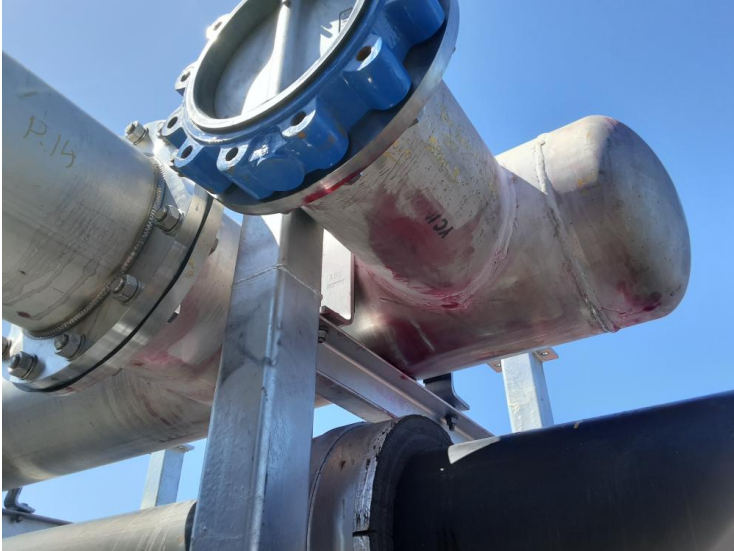
**Image 9 of 9 - Top header South end spool #3 W7-11**

| Identification | Spool No. | Weld No. | Description | Test area | Discontinuities |
|---|---|---|---|---|---|
| South end | Spool 3 | 7 | Top header | Entire Facing east | LS25 @ 12ocl, LS35 @ 10ocl, LS40 @ 9ocl, CC5 @ 9ocl, LS40 @ 9ocl, LS150 @ 5-6 ocl |
| South end | Spool 3 | 8 | Top header | Entire Facing west | LS30 @ 12ocl, LS15 @ 1ocl, CC5 @ 3ocl, CC5 @ 1ocl, LS100 @ 6ocl |
| South end | Spool 3 | 9 | Top header | Entire Facing east | LS10 @ 12ocl, LS10 @ 2ocl, LS10 @ 3ocl, LS15 @ 10ocl, LS20 @ 9ocl, LS30 @ 6ocl, GP2 @ 6ocl |
| South end | Spool 3 | 10 | Top header | Entire Facing west | LS100 @ 9ocl, CC5 @ 5ocl, LS60 @ 7ocl |
| South end | Spool 3 | 11 | Top header | 12-6 Facing south | CC10 @ 2ocl, LS100 @ 6-7ocl |
