## Penetrant test report

**Report number** LW26-0253-02 PT

**Job description** Visible dye penetrant testing on 350NB header weldments

**Identification** Job: VMM00120 NEXT DC M3 STAGE 2; Drawing: SDRG-B-0201-8241

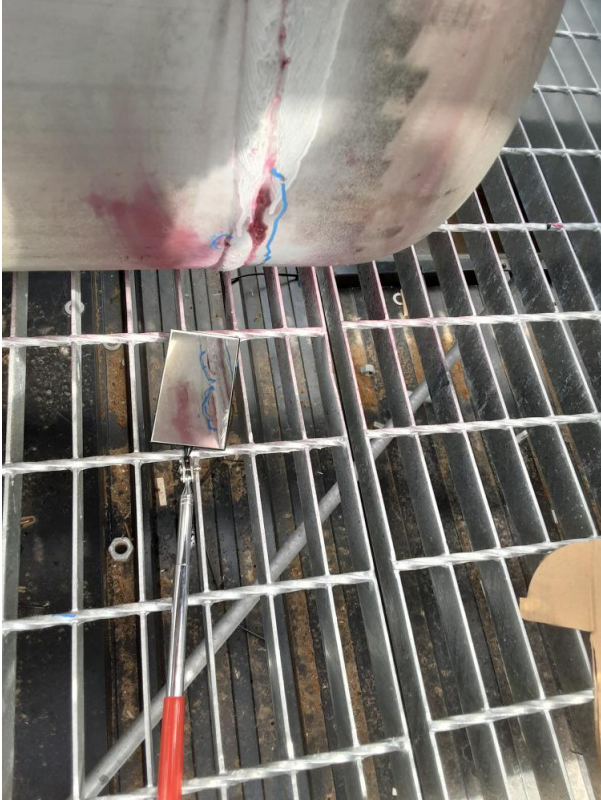
| Identification | Spool No. | Weld No. | Description | Discontinuities |
|---|---|---|---|---|
| North end | Spool 3 | 1 | Bottom header | Multiple lack of fusion areas between 10mm and 200mm, 3-6, 7-10 o'clock |

Image 1 of 13 - BTM SP3 W1: Lack of fusion areas 3-6 o'clock facing north

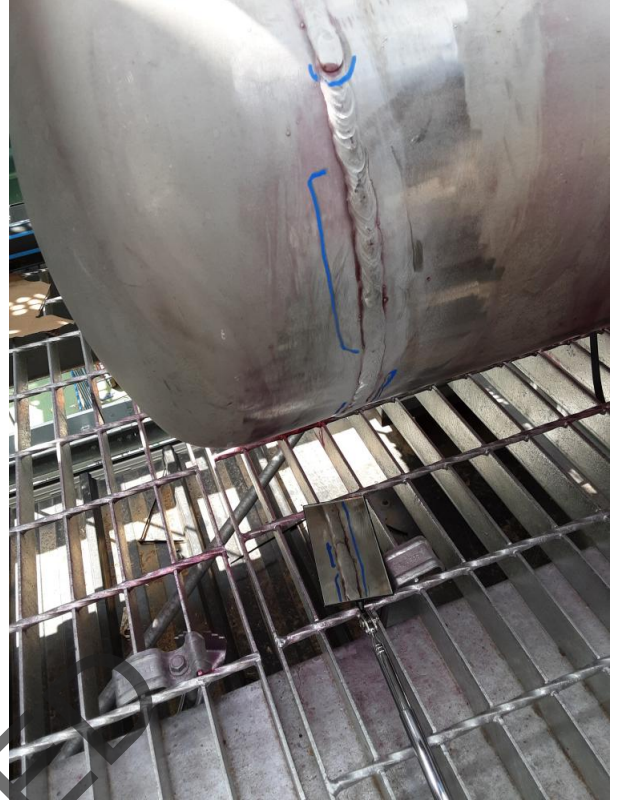
Image 2 of 13 - BTM SP3 W1: Lack of fusion areas 7-10 o'clock facing north

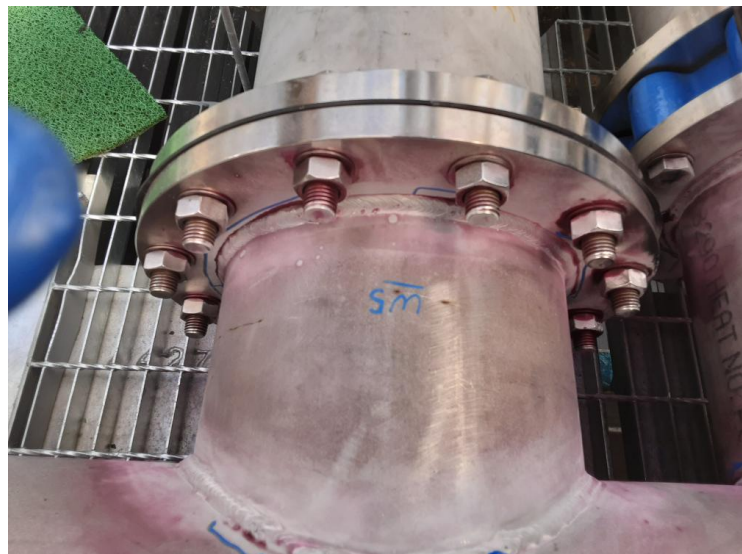
| Identification | Spool No. | Weld No. | Description | Discontinuities |
|---|---|---|---|---|
| North end | Spool 3 | 5 | Bottom header | Intermittent Lack of fusion entire weld length up to 200mm |

Image 4 of 13 - BTM SP3 W5: Intermittent Lack of fusion entire weld length up to 200mm

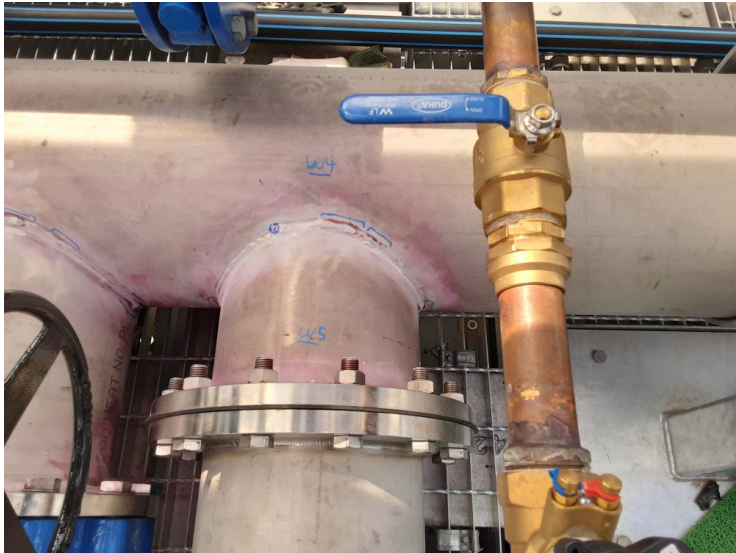
| Identification | Spool No. | Weld No. | Description | Discontinuities |
|---|---|---|---|---|
| North end | Spool 3 | 4 | Bottom header | Intermittent Lack of fusion entire weld length up to 200mm |

**Image 5 of 13 - BTM SP3 W4: Intermittent Lack of fusion entire weld length up to 150mm**

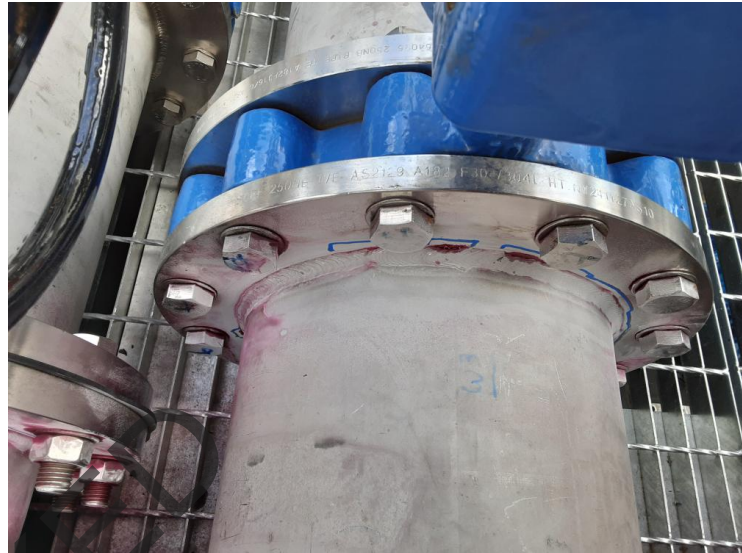
| Identification | Spool No. | Weld No. | Description | Discontinuities |
|---|---|---|---|---|
| North end | Spool 3 | 3 | Bottom header | Intermittent Lack of fusion entire weld length up to 200mm |

**Image 6 of 13 - BTM SP3 W3: Intermittent Lack of fusion entire weld length up to 200mm**

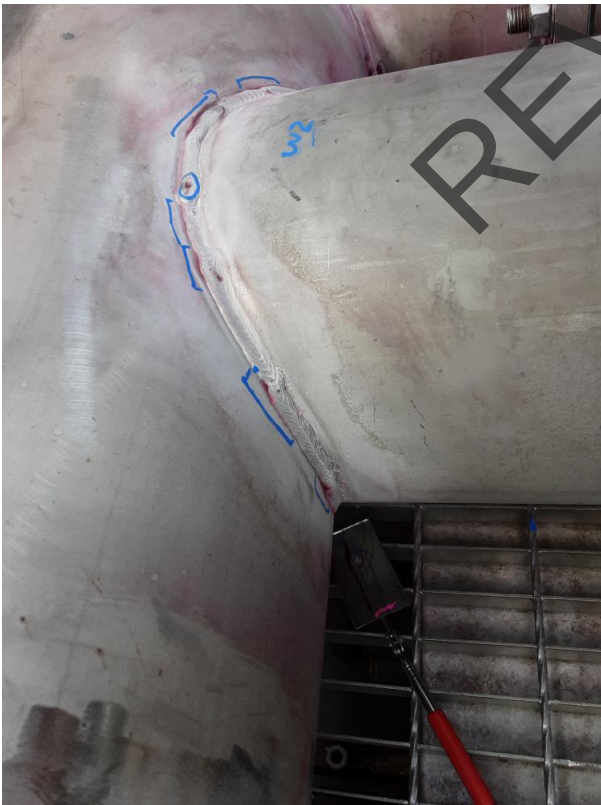
| Identification | Spool No. | Weld No. | Description | Discontinuities |
|---|---|---|---|---|
| North end | Spool 3 | 2 | Bottom header | Intermittent Lack of fusion entire weld length up to 200mm |

**Image 7 of 13 - BTM SP3 W2: Intermittent Lack of fusion entire weld length up to 200mm**

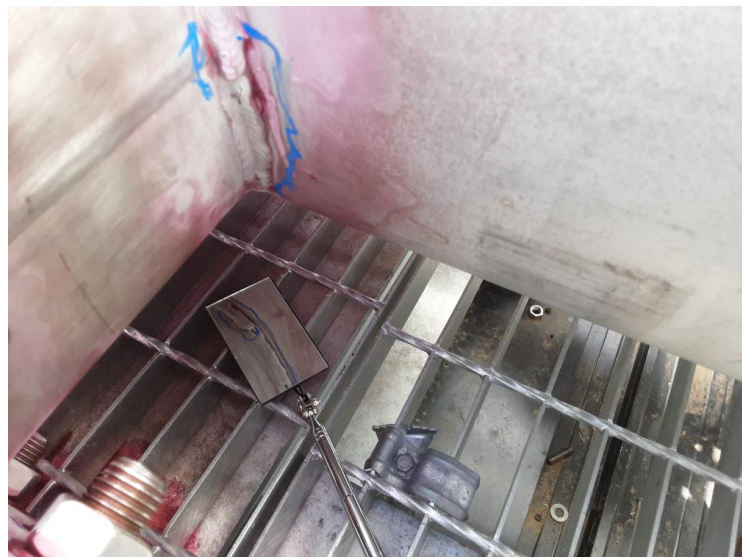
**Image 8 of 13 - BTM SP3 W4: Intermittent Lack of fusion entire weld length up to 150mm**

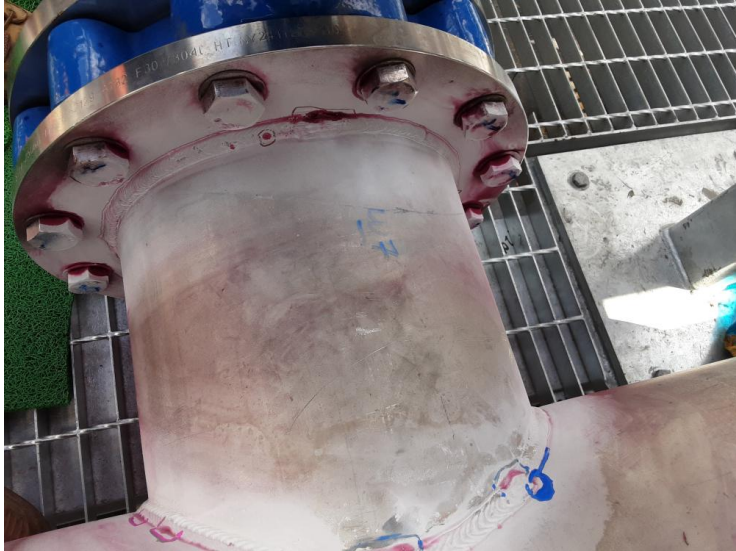
| Identification | Spool No. | Weld No. | Description | Discontinuities |
|---|---|---|---|---|
| North end | Spool 3 | 7 | Bottom header | 4 off locations lack of fusion 6, 12, 3 o'clock up to 100mm facing west |

**Image 9 of 13 - BTM SP3 W7: 4 off locations lack of fusion 6, 12, 3 o'clock up to 100mm facing west**

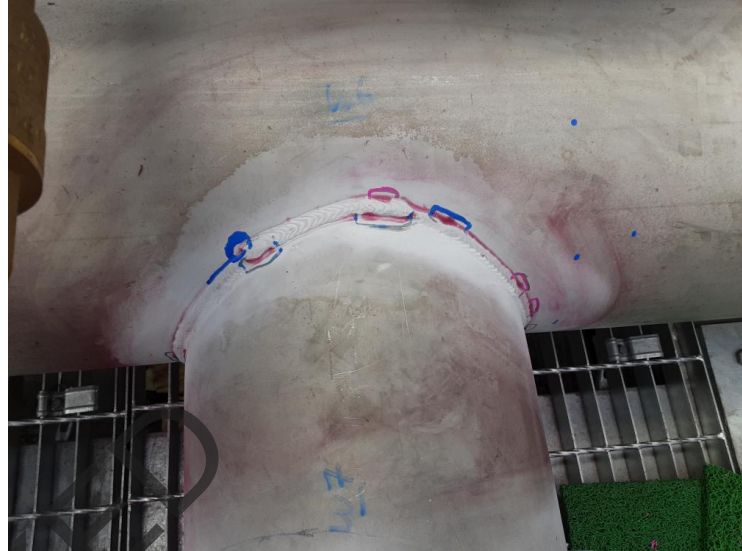
| Identification | Spool No. | Weld No. | Description | Discontinuities |
|---|---|---|---|---|
| North end | Spool 3 | 6 | Bottom header | Intermittent Lack of fusion entire weld length up to 100mm |

**Image 10 of 13 - BTM SP3 W6: Intermittent Lack of fusion entire weld length up to 100mm**

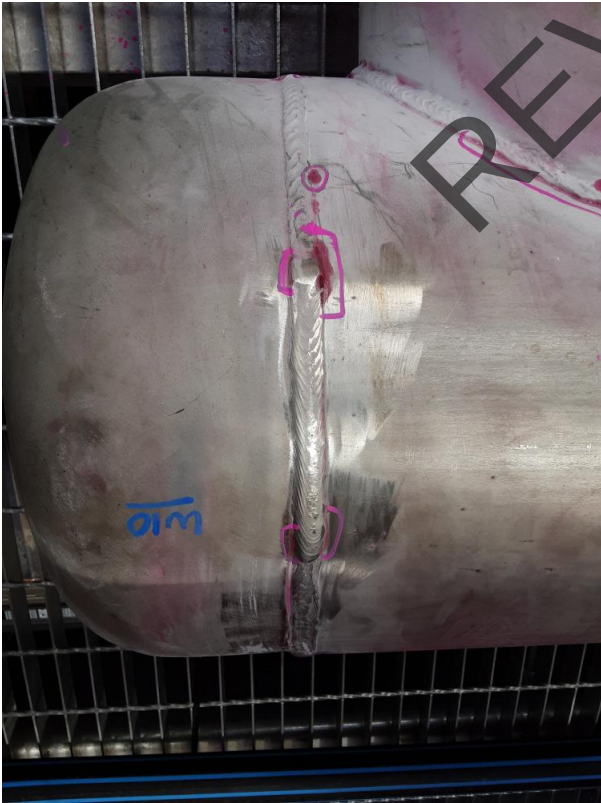
| Identification | Spool No. | Weld No. | Description | Discontinuities |
|---|---|---|---|---|
| North end | Spool 3 | 10 | Bottom header | Intermittent Lack of fusion entire weld length up to 100mm |

**Image 11 of 13 - BTM SP3 W10: Intermittent Lack of fusion entire weld length up to 100mm**

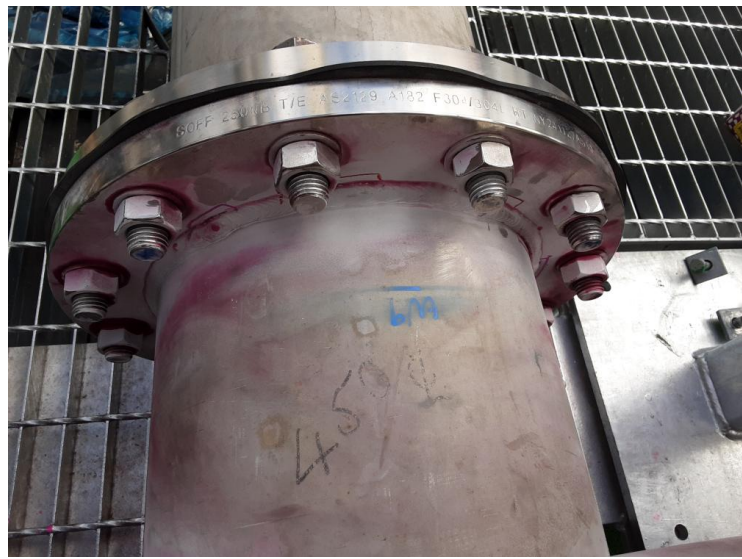
| Identification | Spool No. | Weld No. | Description | Discontinuities |
|---|---|---|---|---|
| North end | Spool 3 | 9 | Bottom header | Intermittent Lack of fusion entire weld length up to 80mm |

**Image 12 of 13 - BTM SP3 W9: Intermittent Lack of fusion entire weld length up to 80mm**

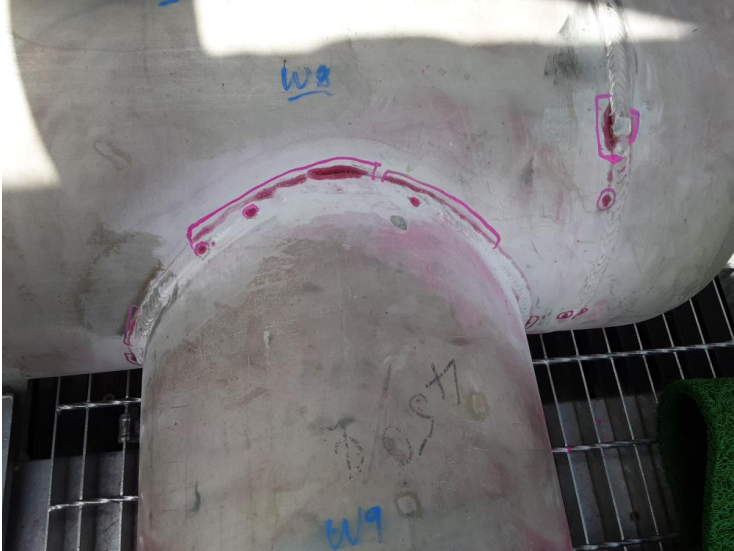
| Identification | Spool No. | Weld No. | Description | Discontinuities |
|---|---|---|---|---|
| North end | Spool 3 | 8 | Bottom header | Intermittent Lack of fusion entire weld length up to 200mm |

**Image 13 of 13 - BTM SP3 W8: Intermittent Lack of fusion entire weld length up to 200mm**
