## Magnetic particle test report

<b>Report number</b>	LW21-1297-1 MT	
<b>Customer name</b>	Asme Welding Pty Ltd	
<b>Address</b>	61 Neumann Rd Capalaba QLD Australia 4157	
<b>Requested by</b>	Kenny Nguyen	
<b>Purchase order</b>	PO-1783	
<b>Accredited laboratory</b>	LMATS Melbourne Laboratory	
<b>Test date</b>	13/07/2021	
<b>Job address</b>	17 Champion road, newport	
<b>Job description</b>	Magnetic Particle Inspection of Weld Repairs	
<b>Identification</b>	Refer to Table 1 (identification provided by the client)	
<b>Material grade</b>	Carbon steel	
<b>Test specification</b>	AS 2885.2 - 2020 - Section 17 - Tier 1	
<b>Test method</b>	AS 1171 - 1998 (Superseded)	
<b>Test procedure</b>	TP-MT-01 (I1,R7)	
<b>Magnetization</b>	Magnetic Flow Method - AC	
<b>Test area</b>	All repaired areas including the surrounding HAZ.	
<b>Surface condition</b>	As welded	
<b>Equipment</b>	L003540 Magflux Y-2 MT Yoke, L0923 Callington Fig.B2 MT Calibration block, L003574 Digital Lux Meter Light meter

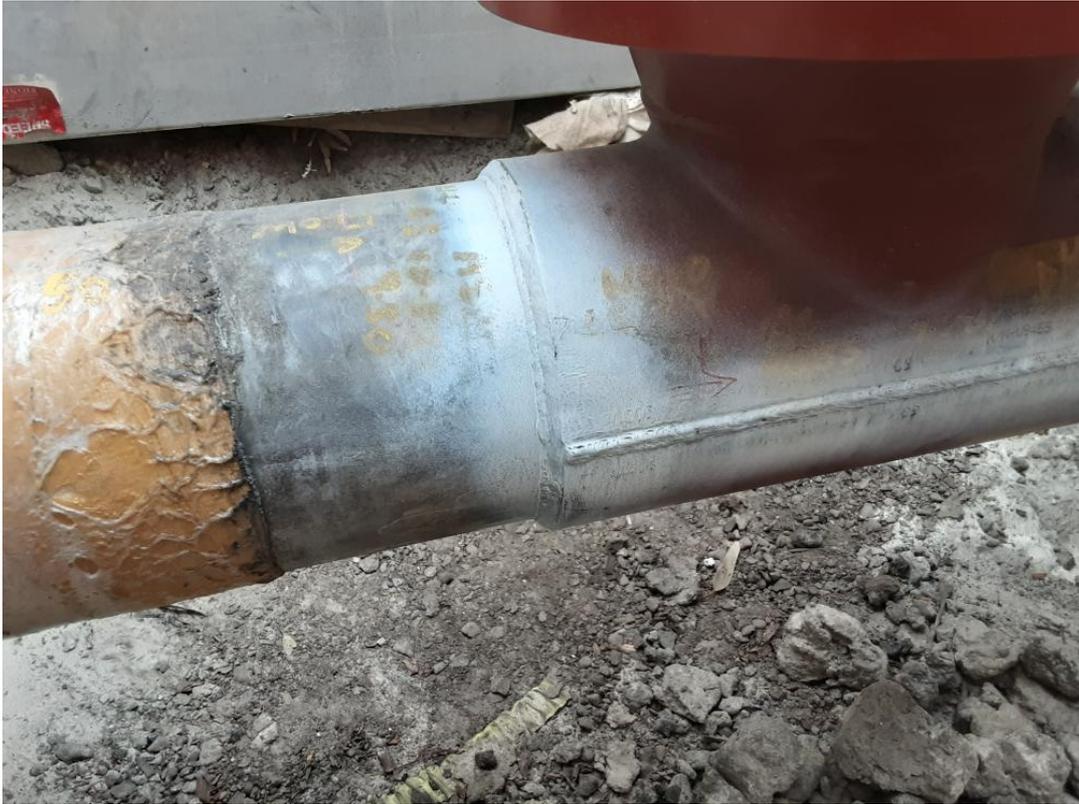
**Image 1 of 2 - General view of the repaired area after inspection**

**Comments** Inspection was carried out on repaired areas only. Refer to photos for further information. No unacceptable surface indications were detected at the time of inspection.

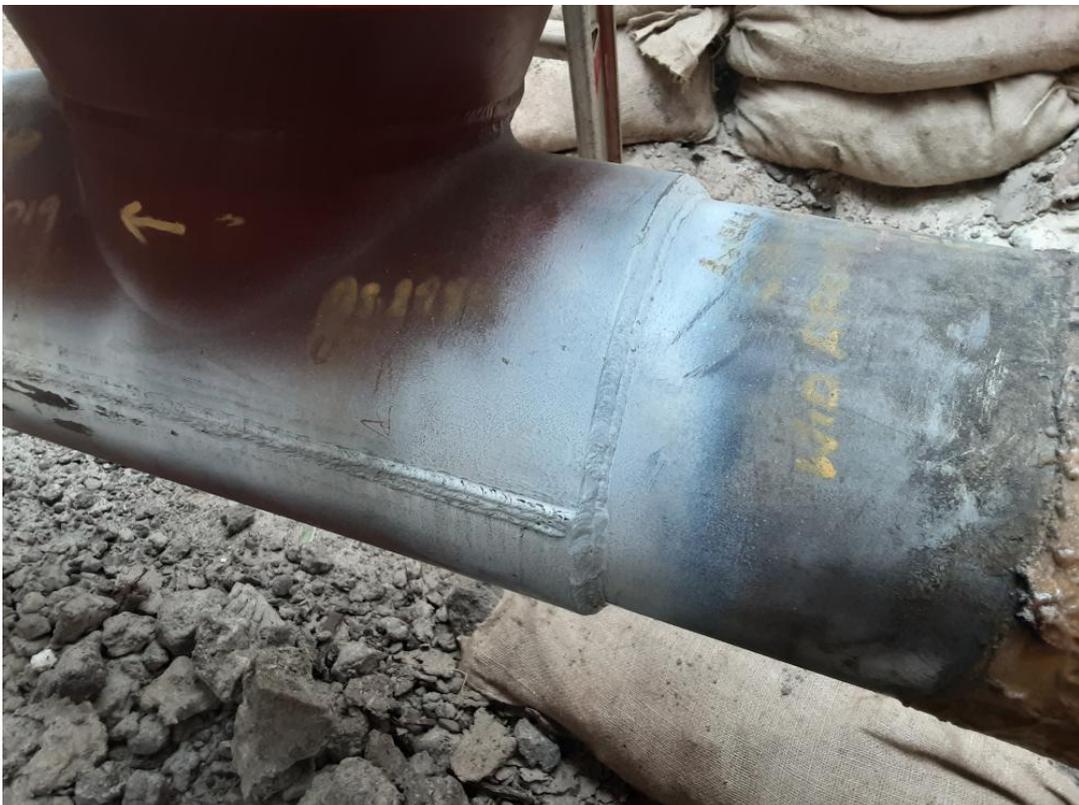
**Image 2 of 2 - General view of the repaired area after inspection**
