## Ultrasonic test report

| Report number | LW25-1903-01 UT |
| Job description | Testing on mobile column lifts - In-service Structural pins |
| Identification | StertilKONI column lifts (4off) - 8 axle pins |

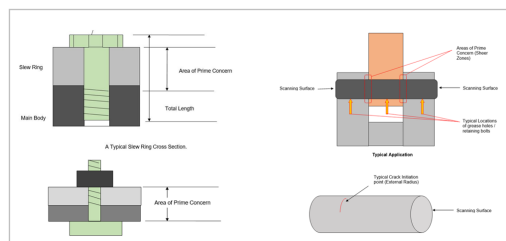
**Scanning plan**

| L-scan | N-scan | T-scan |
|---|---|---|
| NA | Scan from end surface | NA |
