## Eddy current test report

| <b>Report number</b> | NC25-0994-04 ET |
| <b>Job description</b> | Steril Koni Mobile Column Lift Structural Welds |
| <b>Identification</b> | Serial no:-TX162561 Model: ST-1073 FWF Type:- 34408004-02 |

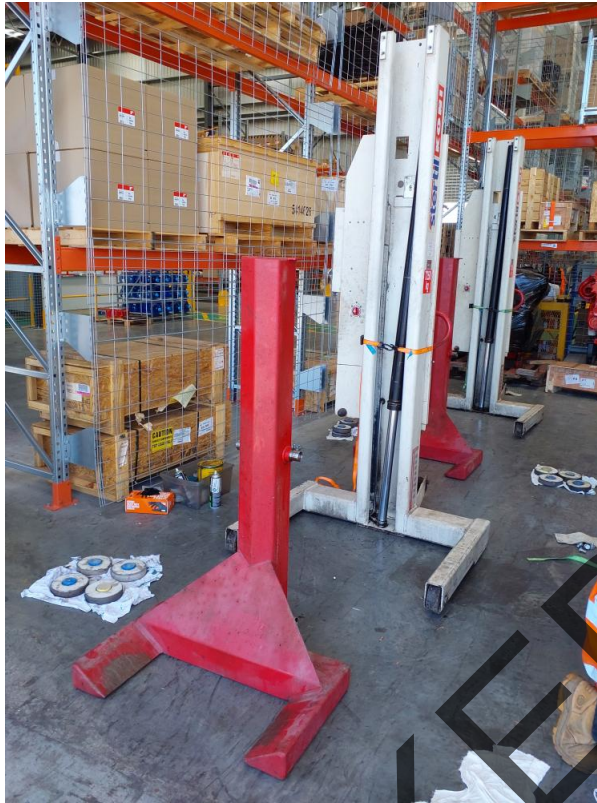
| Identification | Test area | Discontinuities | Result |
|---|---|---|---|
| Column | 100% of accessible structural welds | No cracks detected | C |
| Lifting jib | 100% of accessible structural welds | No cracks detected | C |

Image 1 of 2 - General view of the test area

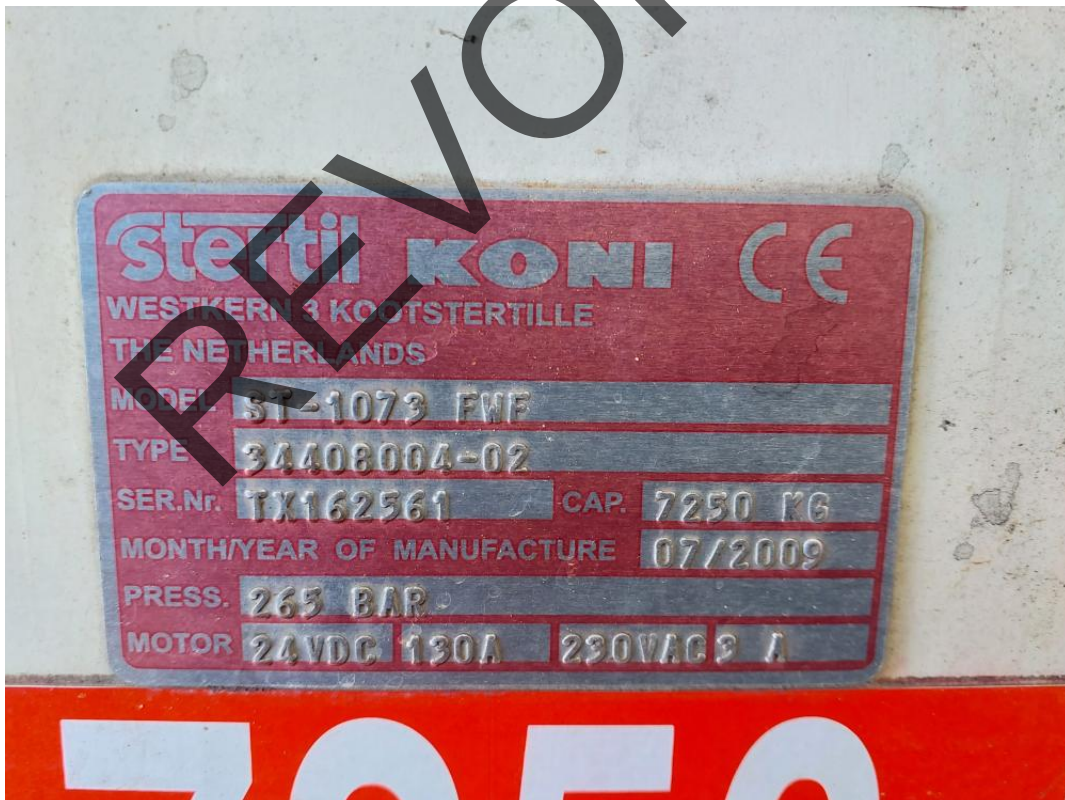
Image 2 of 2 - Identification plate
