## Eddy current test report

| <b>Report number</b> | NC25-0994-06 ET |
| <b>Job description</b> | Steril Koni Mobile Column Lift Structural Welds |
| <b>Identification</b> | Serial no:-TX172202 Model: ST-1073 FWF Type:- 34408054-02 |

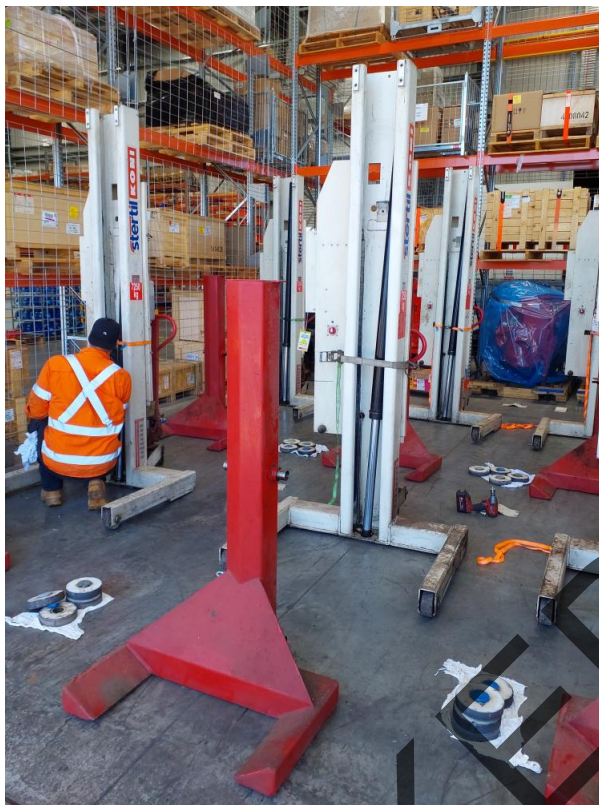
Image 1 of 2 - General view of the test area

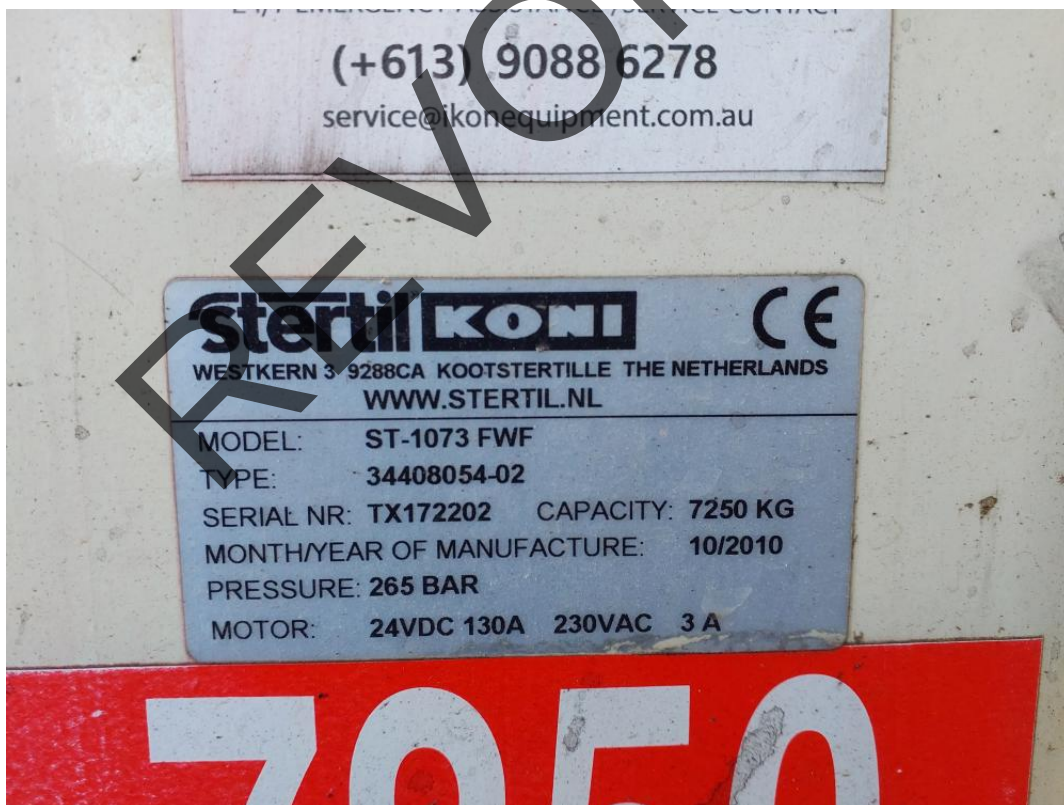
Image 2 of 2 - Identification plate
